# NOOSA SHIRE – WATERWAYS ASSESSMENT 2017

AN ASSESSMENT OF NOOSA WATERWAYS TO INFORM THE  
NOOSA PLAN & REHABILITATION STRATEGIES

September 2017

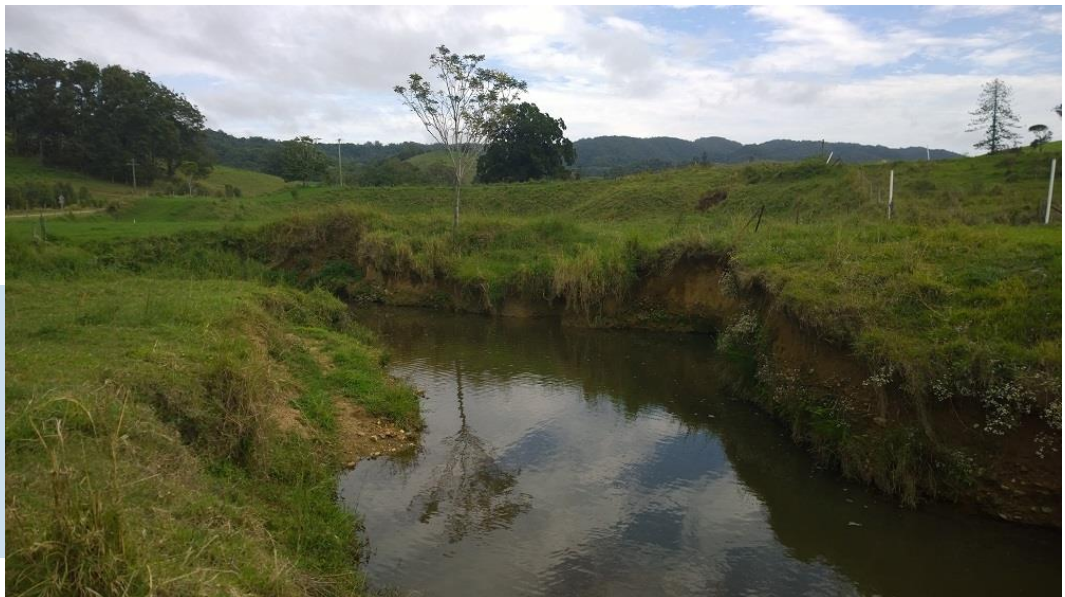
*Pinbarren Creek  
(PIN 1) - Bed and  
Bank Erosion and  
absence of riparian  
vegetation.*

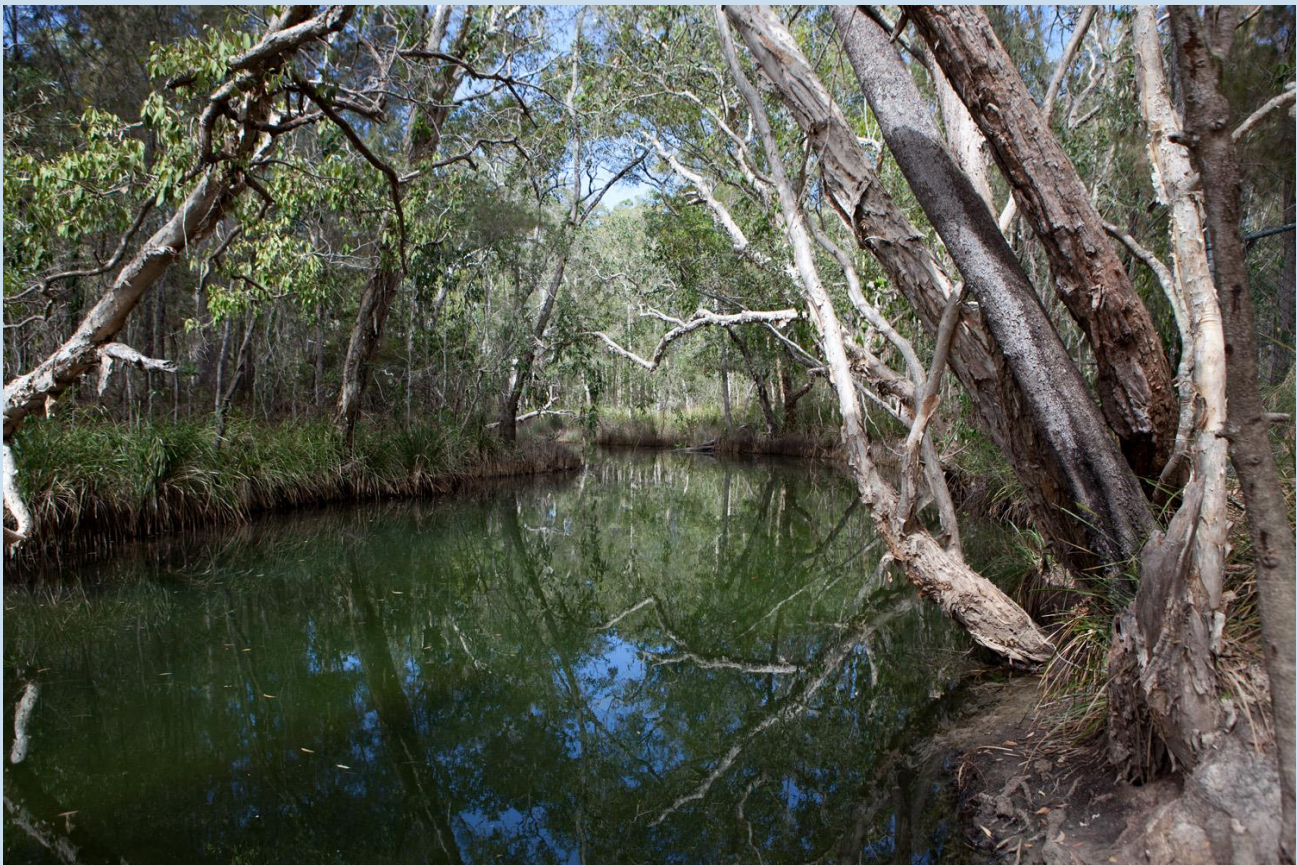
*Cooloothin Creek (WMU – COT 3) – Laterally Unconfined Valley Riverstyle.*

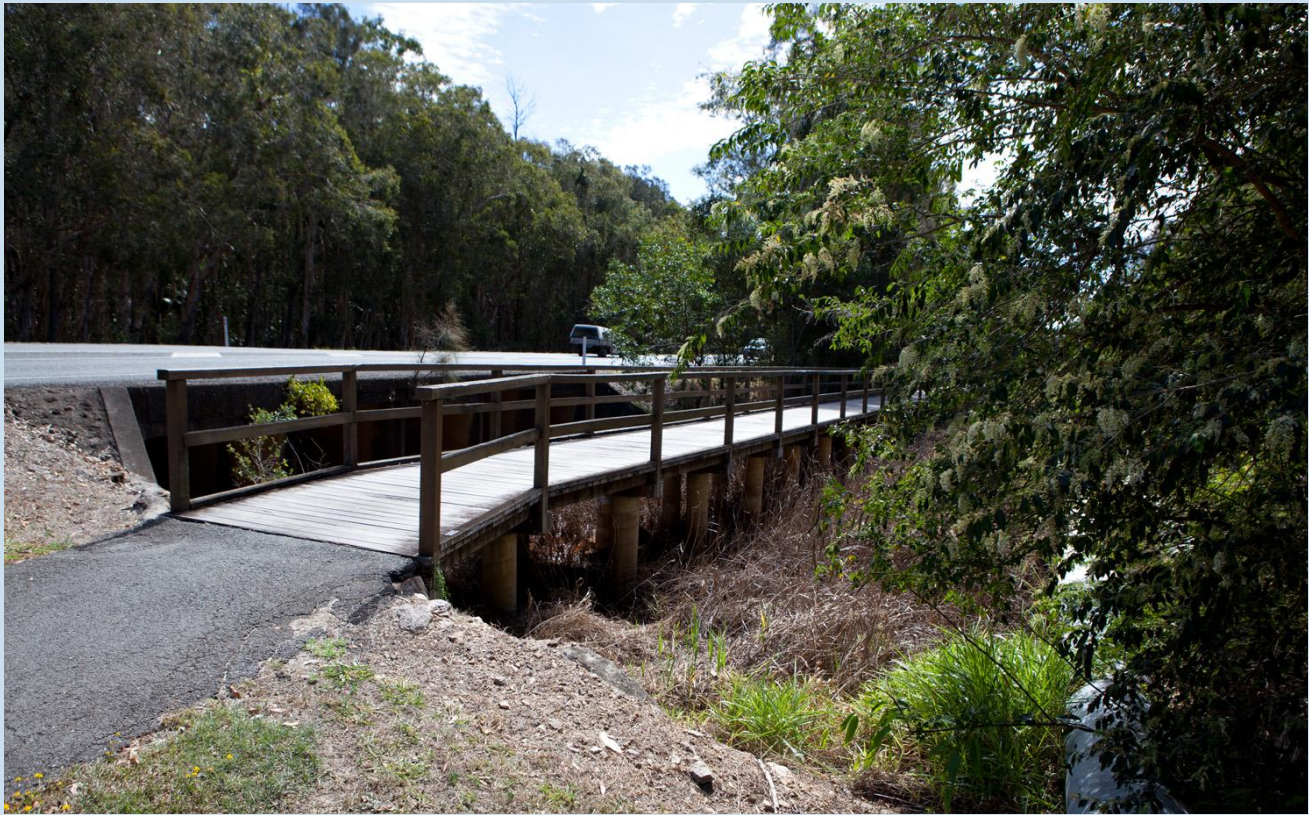
as creating a de-stabilising effect to the culvert structure itself though undermining. Streambed erosion inevitably leads to streambank erosion as the bed of the stream re-compensates for bank stability forming a new angle of repose. Overall there is a general loss of fluvial geomorphic features and habitat diversity required for aquatic life such as fish. An example of this can be observed at Cooroibah Creek on McKinnon Drive. Upstream of McKinnon Drive, the multi-channel Cooroibah Creek flows out of National Park in excellent condition, however below McKinnon Drive the waterway is forced into a newly aligned steep, deep single channel of low geomorphic diversity eventually re-entering the original waterway at Four Ways reserve. The creek also crosses a sewage pipeline which is likely to have compounded the reason for the stream realignment.

*Cooroibah Creek (COH3/4), on entry to 4 Ways Reserve – A Multi-channeled creek has been realigned due to road and pipe infrastructure, causing streambed alterations and aquatic habitat condition decline.*

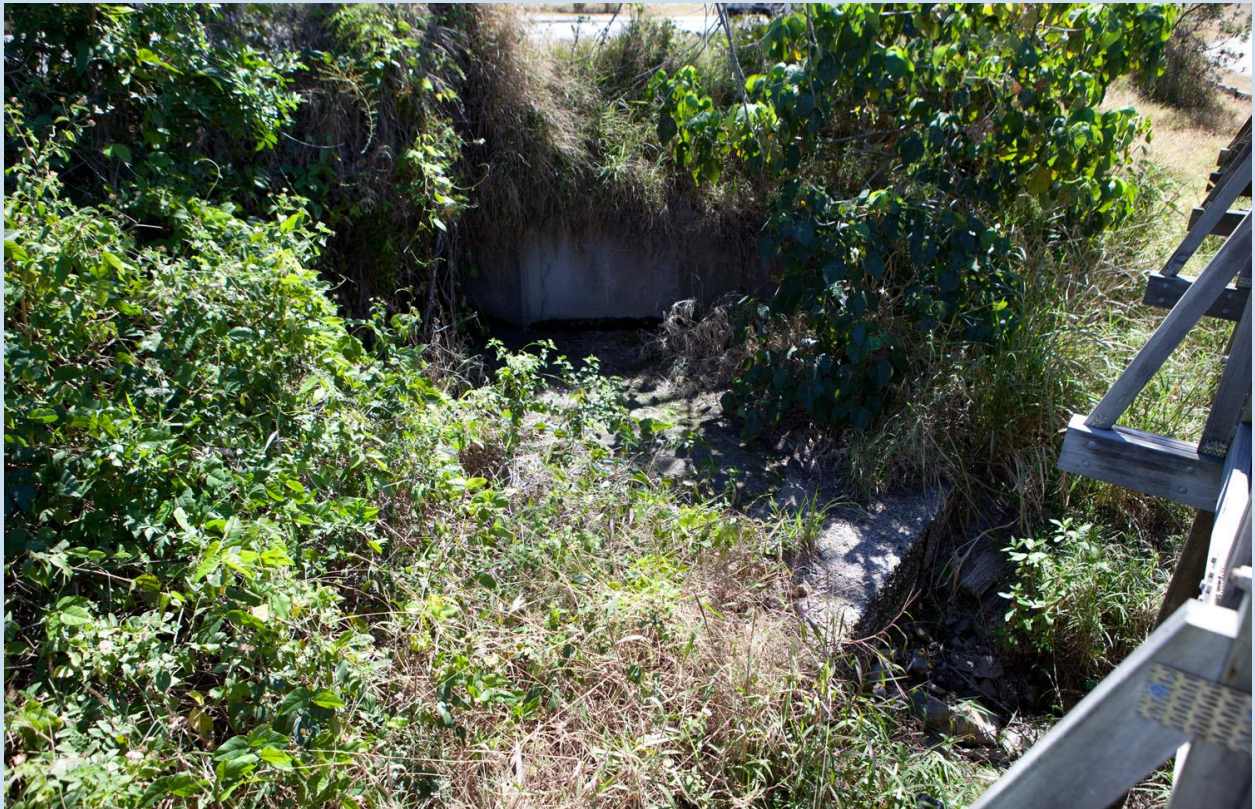
A common issue observed was the difficulty passing a broad waterbody into a single culvert point when these waterways became urbanised near housing or road networks (similar issues to that examined above). These waterways are relatively steep in their lower catchment which poses difficulties locating road culverts (particularly on David Low Way), without a significant 'drop-off' that causes fish passage and stream bed erosion issues. A good example is Marcus Creek on David Low Way. Significant weed infestations were observed near urbanisation which additionally degrades the integrity of these waterways.

*Marcus Creek at David Low Way (MCS 2) – Single Culvert crossing with significant 'drop-off' causing fish passage restriction and stream bed erosion.*

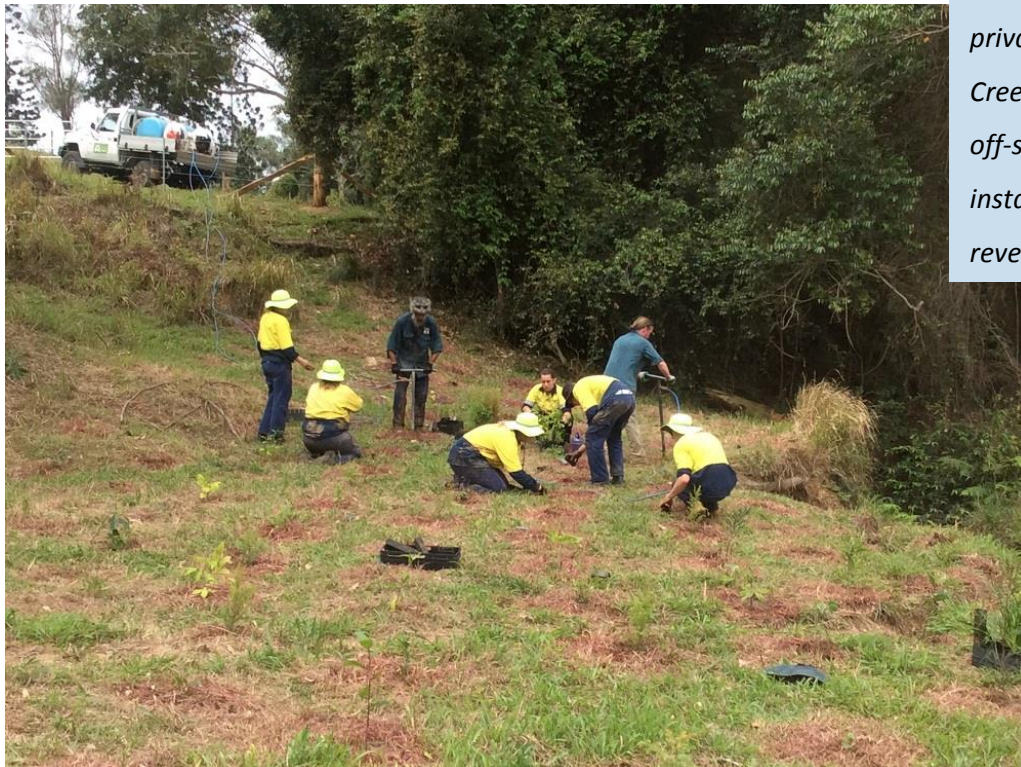
*Riverbank restoration work on private property in Wahpunga Creek (WAH 2) involving fencing, off-stream watering point installation and riparian revegetation.*

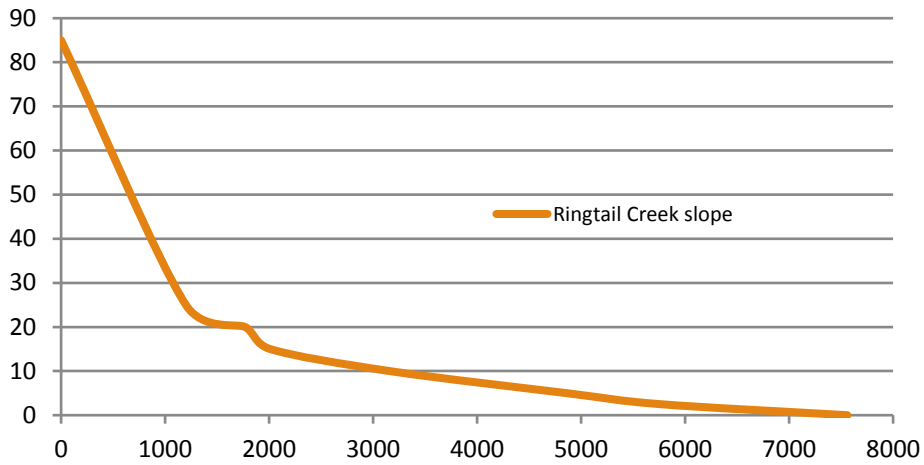
### Ringtail Creek slope

The longitudinal slope profiles of these waterways (Examples contained in Appendix 2) are relatively steep along their entire length.
