Winter 2024.

Noosa's Huon Mundy reefs update

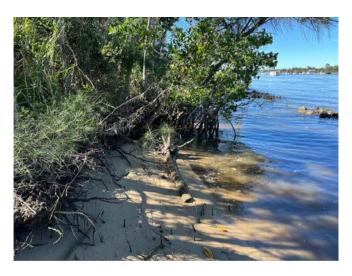
Waves generated by storms and boat wake are a major shoreline erosion problem in modern day estuaries. Noosa is no exception. For example, erosion at Goat Island is undercutting the southern bank (Figure 4), causing trees to die and collapse into the river. The exposed sediments are then readily washed away, exacerbating river turbidity and sediment levels. A common response is often to fortify the shoreline with rock seawalls, or other hard materials, which can increase wave refraction, which exacerbates erosion elsewhere.

Figure 4 Erosion and undercutting at Goat Island. Photo S. Walker

Shellfish reefs, however, can be used to great effect in the fight against coastal erosion. They can be designed to attenuate waves while minimising wave refraction. They also provide benefits to nature. The shellfish reefs at Goat Island are showing just that. Monitoring has shown that erosion shoreward of the Goat Island reefs has been halted and sand is building up between the shoreline and the reefs. Mangrove propagules have also begun to settle and establish on the sand build up, adding to the shoreline protection offered by the reefs. However, between the reef patches and up and downstream of the reefs, wave action continues to erode and threaten Goat Island.

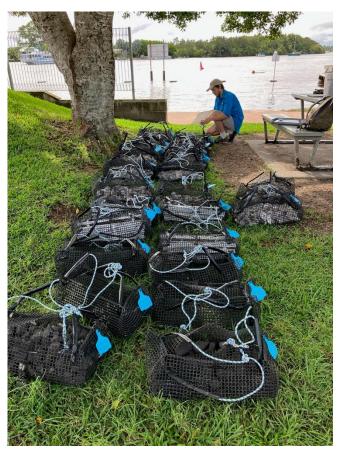
NICA has also established additional oyster gardens (Figure 7), as experimental plots as we seek to understand what surfaces oysters prefer to settle on (for example, rough or smooth oyster shells). The team has also commenced experiments to reveal at what stage of their life oysters become less vulnerable to predation, particularly from fish. This will help us identify the best moment to release oysters from the gardens back into the restored rock oyster reefs.

Figure 7 Setting up additional oyster gardens for settlement trials Photo R. Howard
