Old Ceylon Road, Ridgewood – reconstruction complete

Project summary

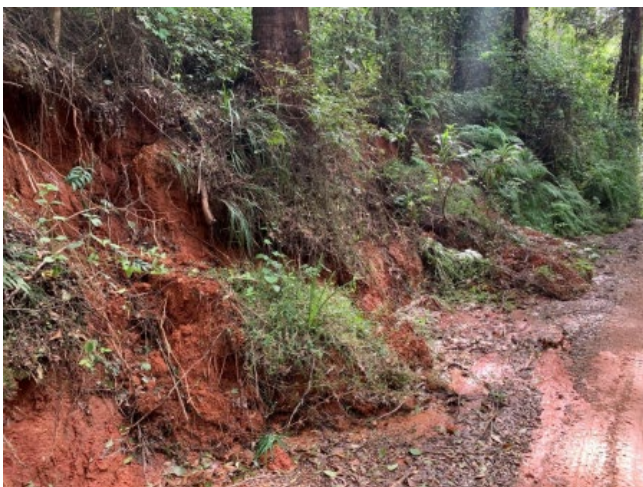
Old Ceylon Road sustained significant damage during the 2022 flooding and rain event, with multiple landslips and slumps impacting the stability of the slope near 130 Old Ceylon Road.

Damage to the slope on Old Ceylon Road

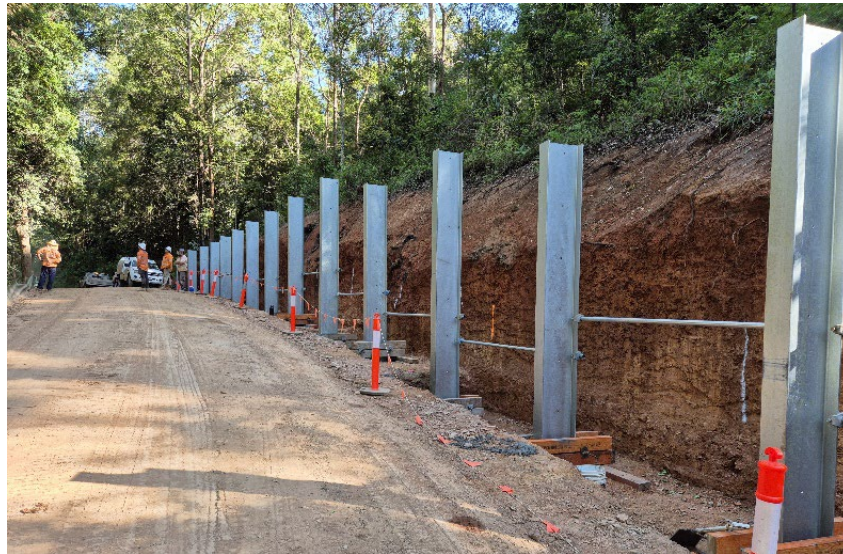
Supporting columns for retaining wall. These columns are 5.1m below ground.

This included supporting columns going 5.1m below ground and the wall being up to 4m above the existing road.

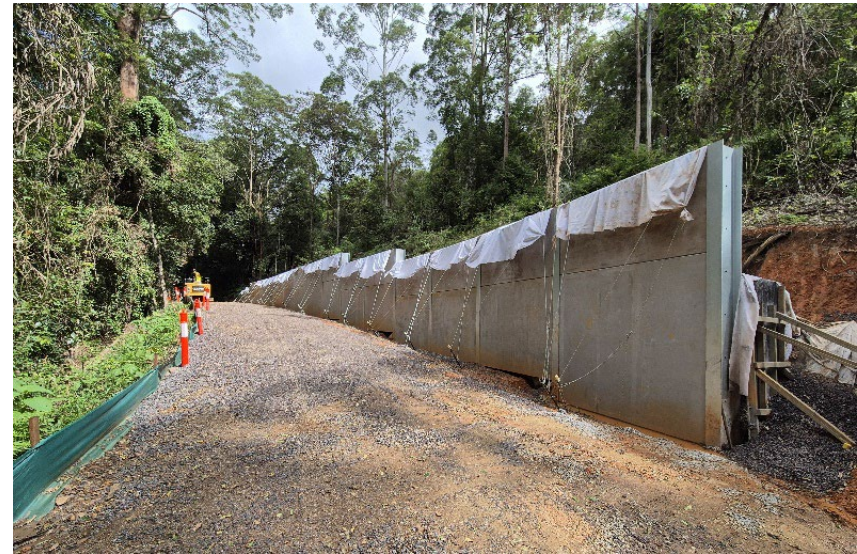
Main retaining wall structure reaching up to 4m above the existing road.

- excavation of unsuitable material
- constructing a retaining wall designed to withstand future slides.

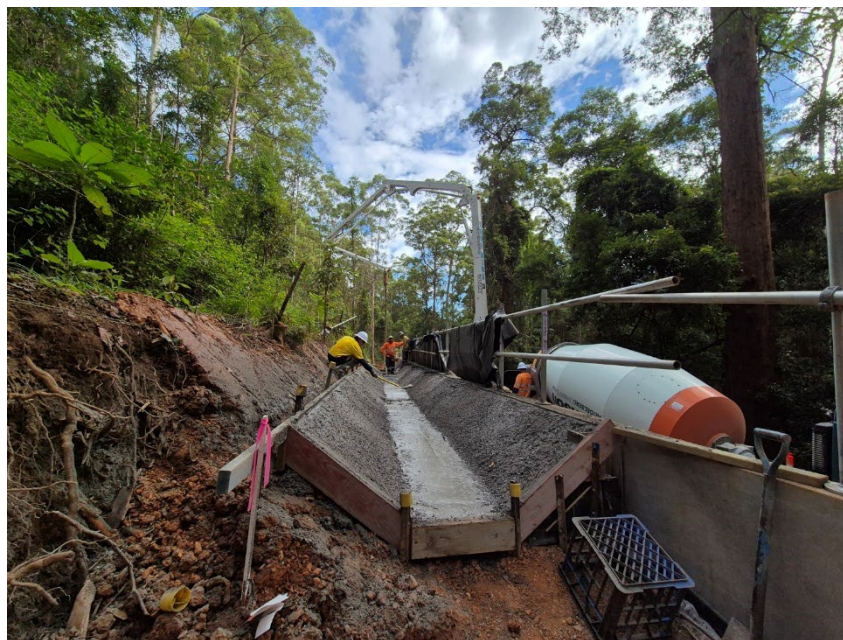
Putting in the shotcrete drain at the top of the retaining wall.

- a shotcrete drain at the top of the wall to redirect water
- reinstating table drain adjoining the road
- reconstructing road pavement.

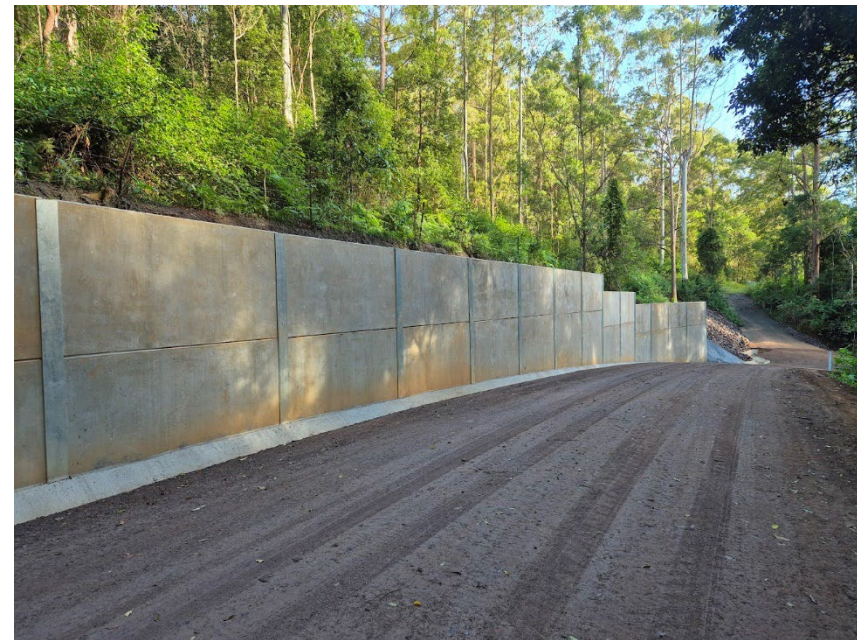
Completed reconstruction work and road re-opened to traffic.

Noosa Council is pleased to advise FKG Civil Pty Ltd has now completed reconstruction works, with the road now restored to normal operation.
