July 2024

## Cootharaba Road, Cootharaba

The 2022 flooding event caused landslide damage to a section of Cootharaba Road, Cootharaba.

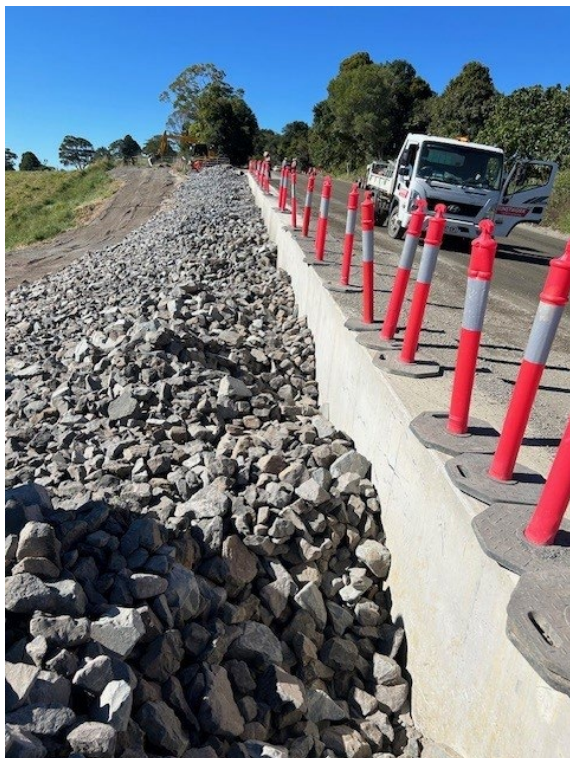
Rock protection

- 38 piles (900mm diameter and 12.5m long) and 23m soil anchors installed to provide long-term stability
- constructing a retaining wall 70m long and 4.5m high, which was tied to the piles to withstand future slides
- slope rock protection, with 1500m<sup>3</sup> of rock placed
- drainage improvements
- pavement reconstruction
- sealing works.

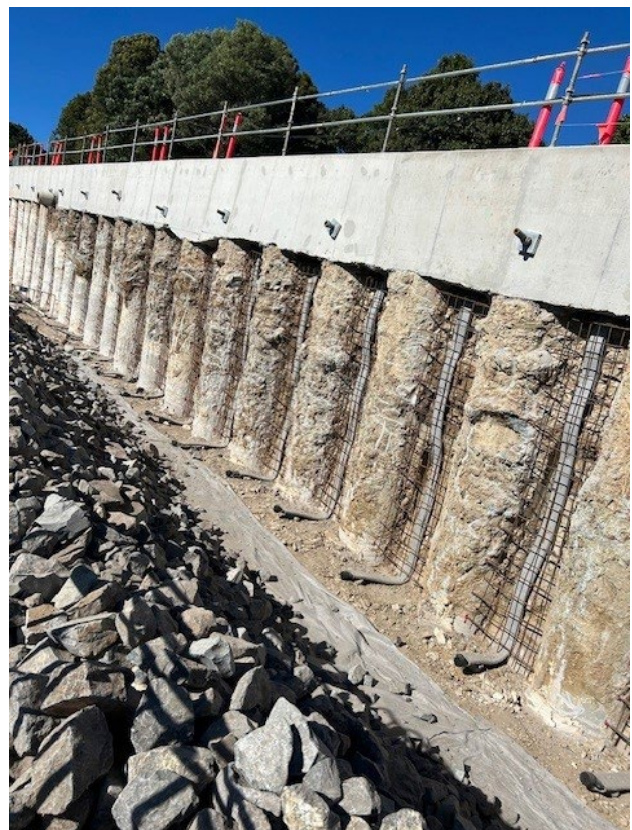
Retaining wall

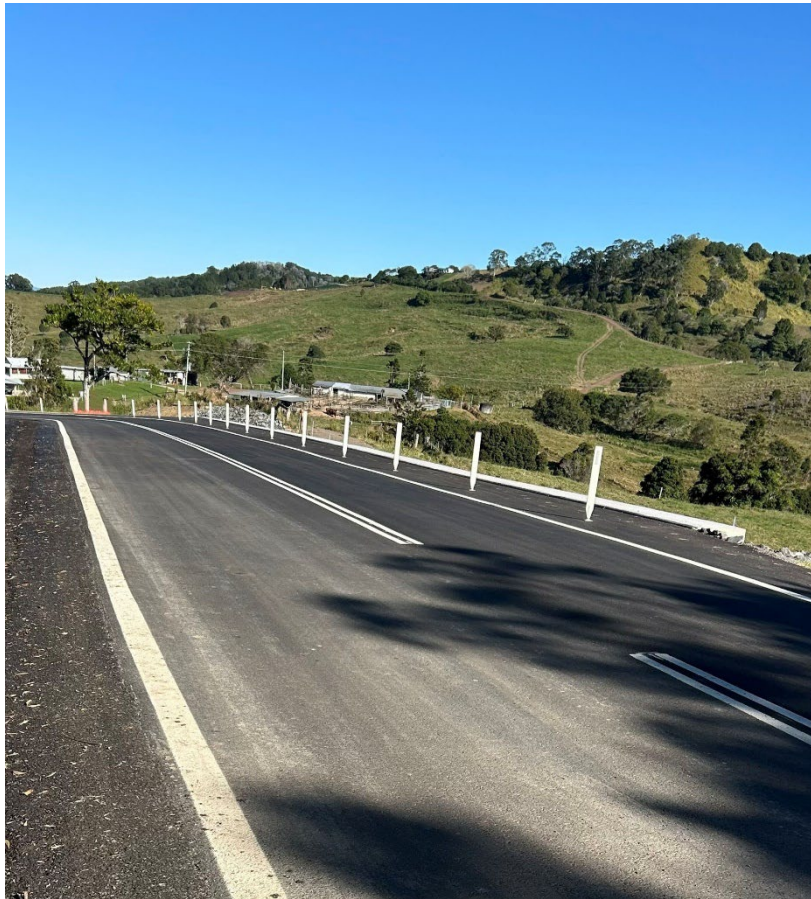
*Completed works on Cootharaba Road - July 2024*

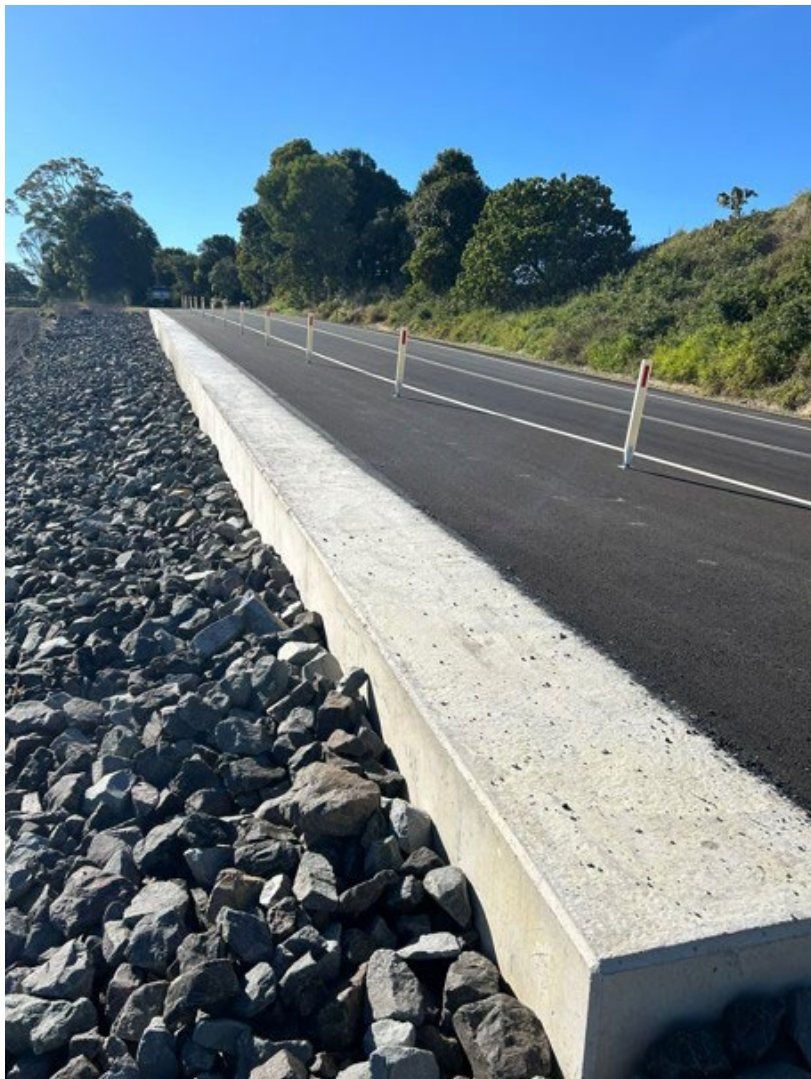
*Completed works on Cootharaba Road - July 2024*
